## US National Weather Service Cheyenne Wyoming

...NWS DAMAGE SURVEY FOR 06/06/20 TORNADO EVENT NORTH OF TURPIN RESERVOIR  
IN THE SNOWY RANGE...

#### .TURPIN CREEK TORNADO...

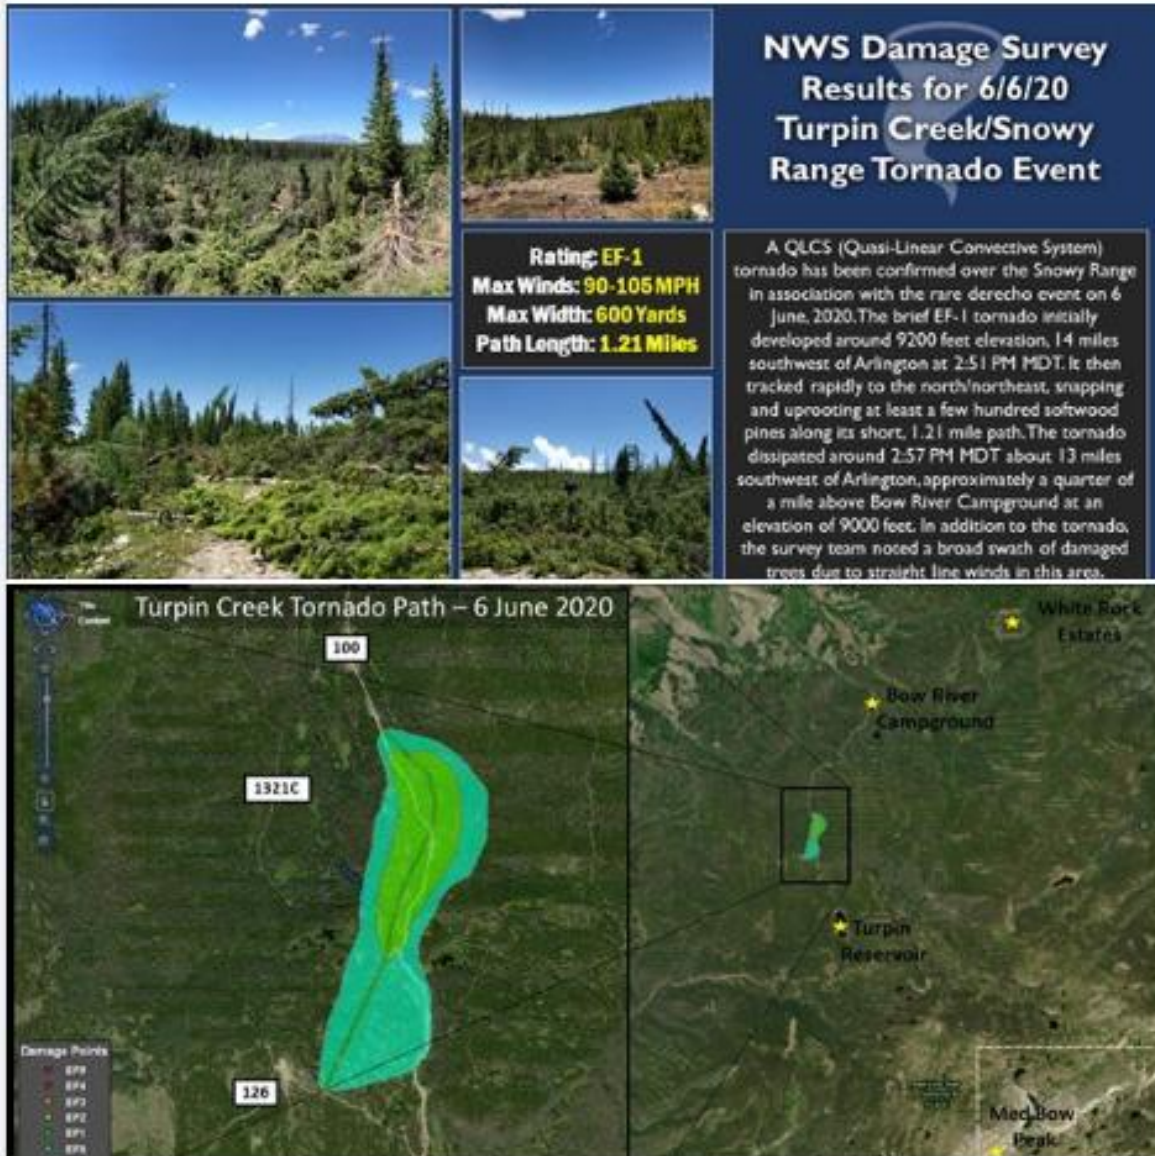
A tornado has been confirmed in the Snowy Range north of Turpin Reservoir during last Saturday's (6 June 2020) rare derecho event. Our office conducted two surveys on the damage path Monday and Thursday. The short-lived tornado snapped and uprooted hundreds of trees along a 1.21 mile long path that was up to 600 yards wide at one point. Based on the damage, maximum estimated wind speeds were 105 MPH which rates this tornado as an EF-1.
